7.0 Preventing Falls on Steps and Stairs

Falls on steps and stairs, even short flights, can result in serious injuries and even fatalities. Key to preventing this is good stair design that reduces the risk of human error.

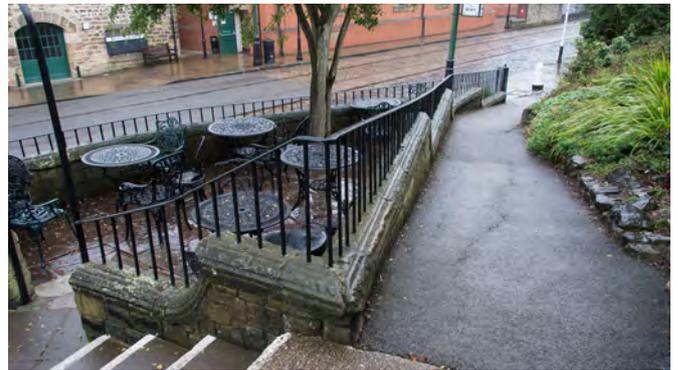
Good use of handrail that runs the full length of access routes, plus clear nosings and a ramp.

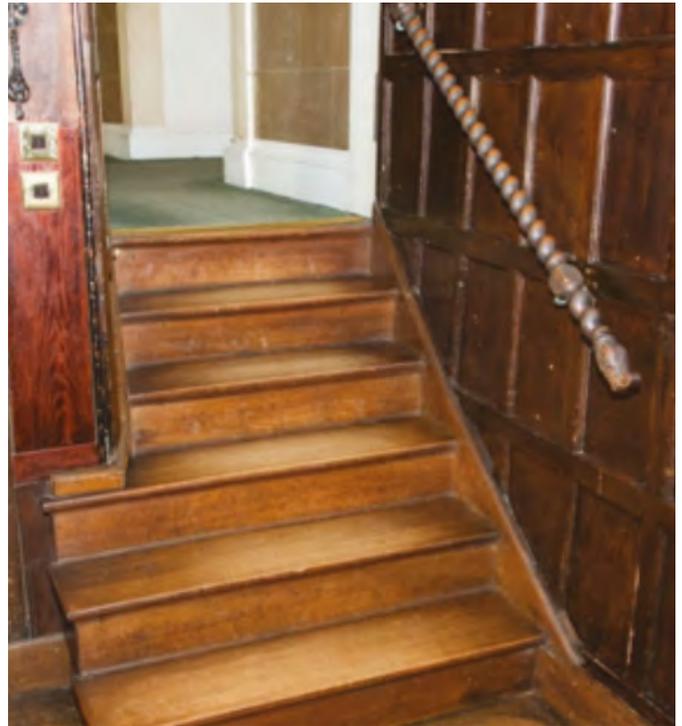
Attractive and successful historic handrail design

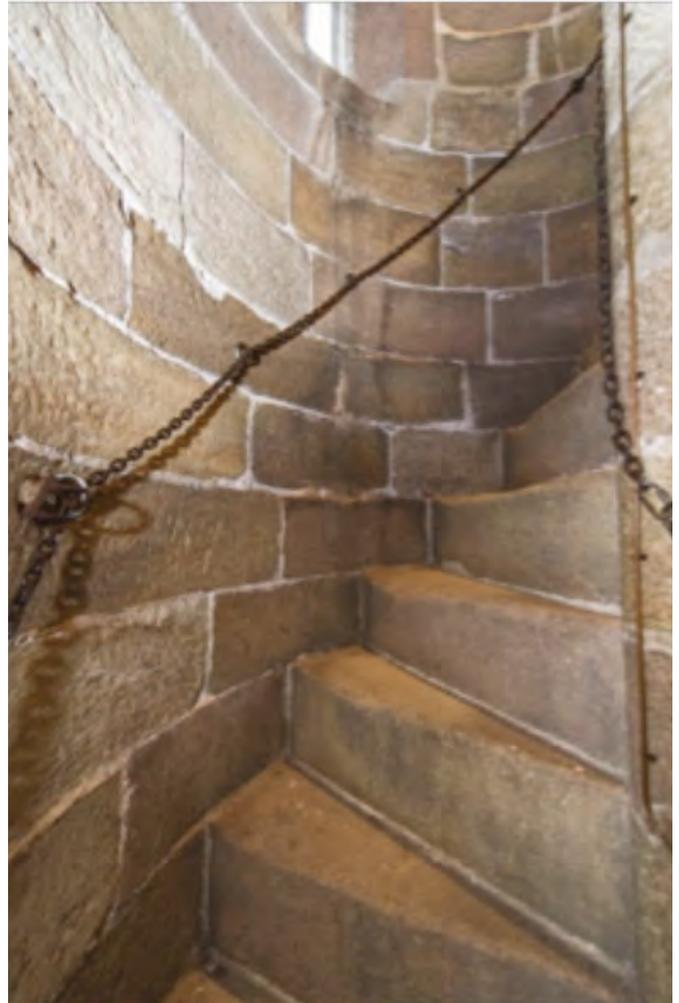
Using a one-way system for access where stairs are particularly narrow can reduce the risk of falls.

- Use a one-way system for access where stairs are particularly narrow.
- If stairs to some parts of the premises are particularly challenging to use, consider providing other means of viewing these areas (e.g. a webcam or short video showing the area of site accessed by the stair). This gives people the option to view these parts of the site without having to use stairs they are not confident on.

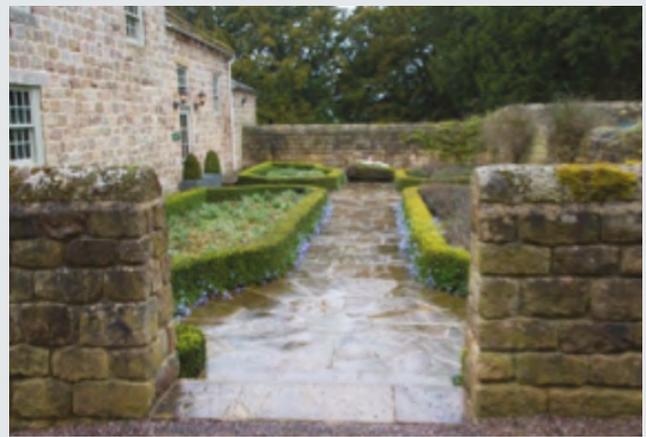
Concealed steps

Many stairs in historic properties will have poorly defined nosings. Sometimes this will be compounded where the stairs have become worn.

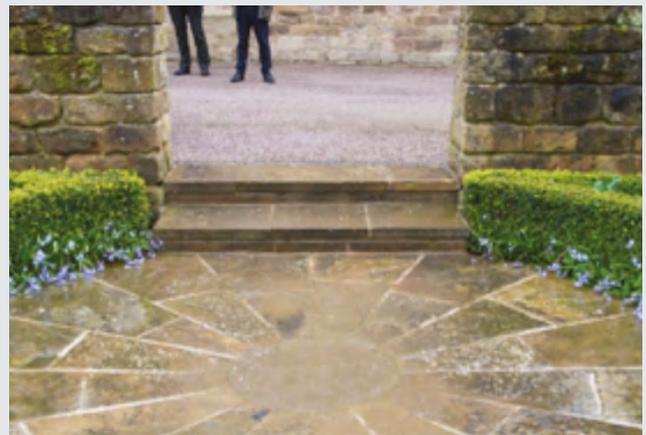
Same steps from another angle

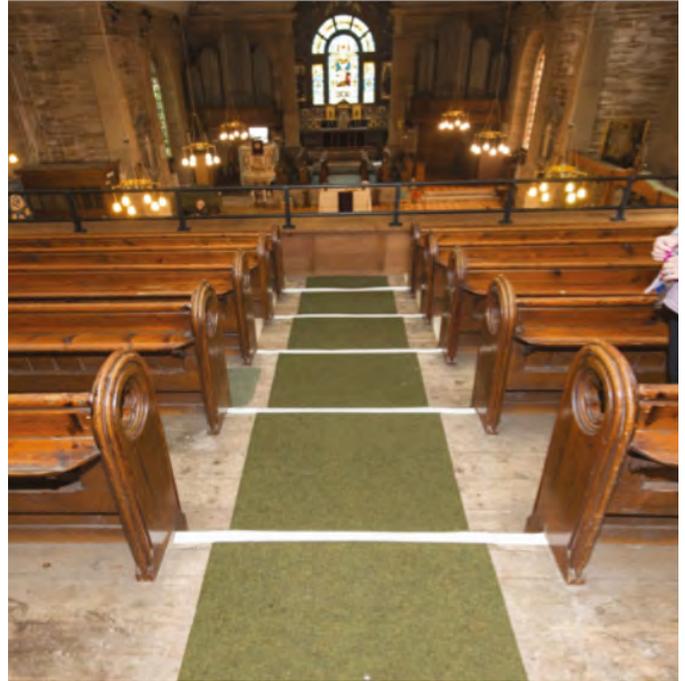
Effective nosing highlight

Stairs should have a contrasting nosing to highlight the edge of each tread. A well designed nosing highlight should:

- **Be present at the very edge of the tread.** A highlight set back from the very edge gives a misleading impression of where a person is to place their feet.

- **Extend across the entire width of the tread.**
- **Be approximately 50mm – 60mm deep** to give suitable definition without covering a significant amount of the tread itself.
